Analysis of shoreline change and the problem of saltwater intrusion: A case study on south-eastern part of Sagar Island, West Bengal, India

Shilpa Saha *

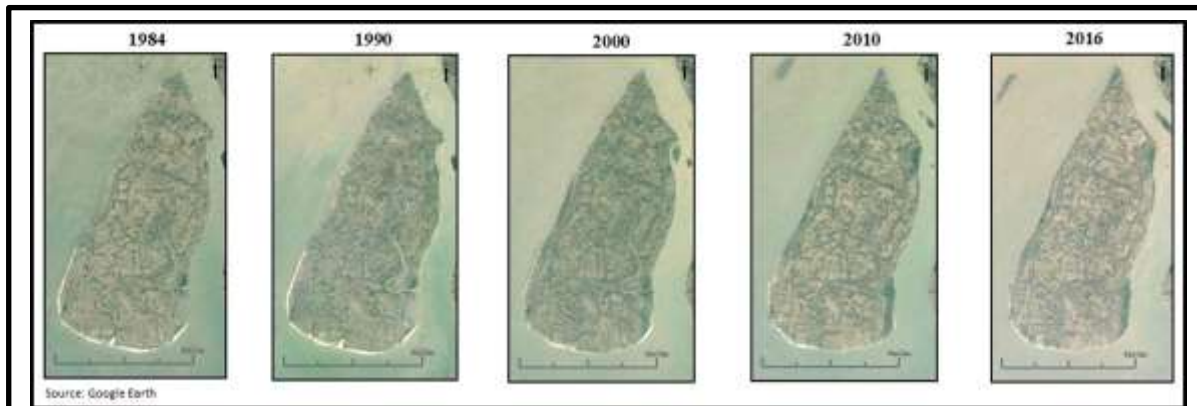
Figure 3. Change in the Configuration of Sagar Island [Source: Google Earth]

With the help of Google Earth, five images of Sagar Island for the years 1984, 1990, 2000, 2010 and 2016 have been analysed for depicting the change in the configuration of the island. It is observed that the size of the island increases in

2016. In 2000, a small part of a broken island is attached to the north-eastern part of the Sagar Island. It is found that in 2016 the area under mangrove also increases in the south-eastern part of the island which is now under the threat of further degradation. Due to the breaching of the embankment, the problem of coastal erosion is increasing in the southern part of the island [17]. The northern peak of the island is now under the influence of accretion and naturally growing mangroves. It indicates that both the processes of erosion and accretion are working together around Sagar Island.

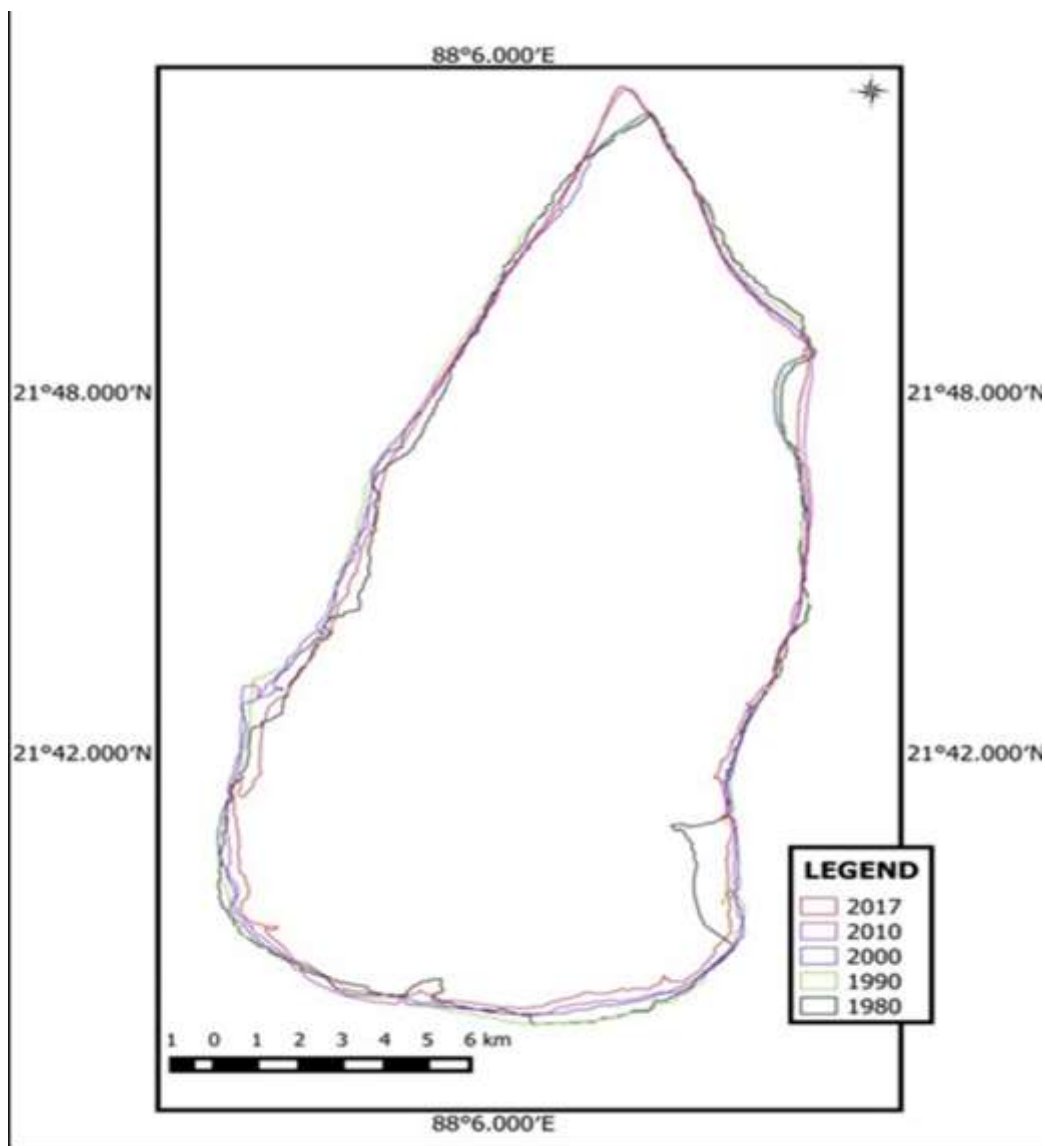
Figure 4. a) Spatio -Temporal Change of Sagar Island (1980-2017)

clay [15]. It can more easily be eroded by waves, tides and cyclonic activities [15]. It is evident from our observation that the total area of the Sagar Island in 1980 was 208.690 sq km. Since then, the accretion activity started in the region resulting in the increase of the land area. In 1990, the amount further increases to 248.020 sq km. Severe cyclonic storms and sea level rise were responsible for the erosional activity in the region. In 2000, the land area decreases to 242.784 sq km. With the impact of accretion processes in the region the total land area increases to 247.248 sq km in 2010. The embankment had been constructed to save the land encroachment by the sea. But due to the weakness of the embankment creating material, the embankment has been incapable of facing the encroaching sea waves. Severe erosional activity along the Coast of Sagar Island is responsible for the change in the area to 236.497 sq km in 2017.

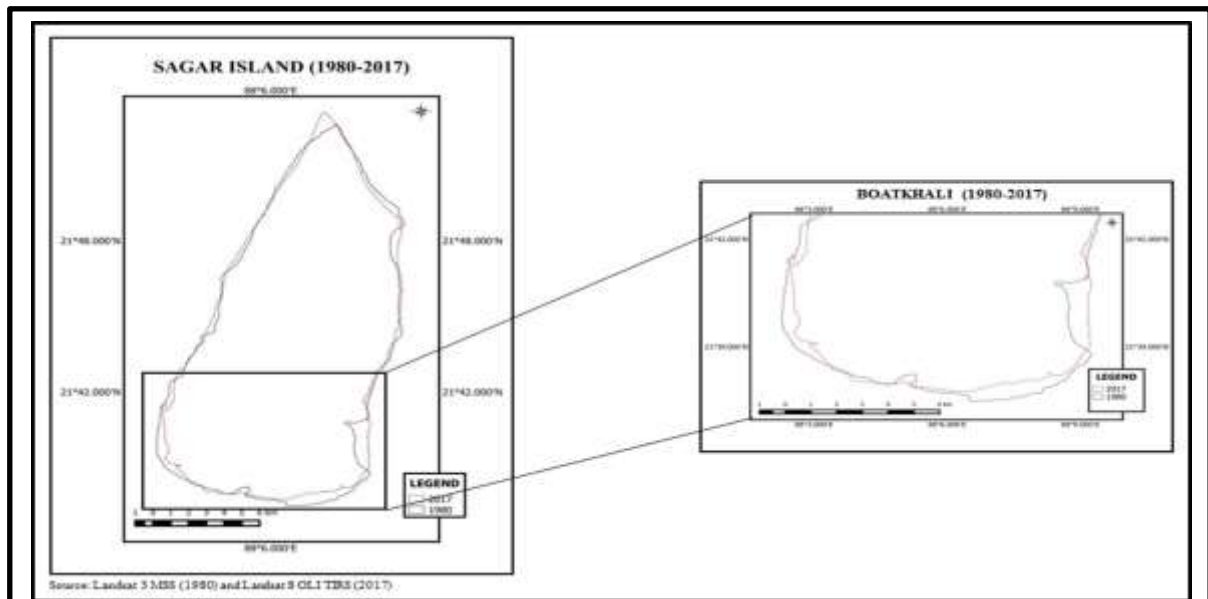
Figure 5. Shoreline Change in Sagar Island (1980-2017)

The Sagar Island in the Sundarbans delta is composed of mainly silt and clayey sediments. The island has been under the impact of severe coastal erosion. The sea-facing southern part of the island mainly comes under the impact of the high energy waves during the monsoon period when destructive wave climate, increased occurrence of tropical cyclone and raised sea levels are mainly the causes of erosion along the coastline [25-27]. For assessing the shoreline change in Sagar Island and its south-eastern part i.e., the Boatkhali region, the satellite images of 1980 and 2017 have been taken (figure 5). It can be observed from the map of Sagar Island that in the south-southeast, north-northeast and southwest section, the land is under the influence of erosion. On the other hand, in the north, northeast, west and southeast section of the island, the land is getting deposition. In the case of the Boatkhali region it is found that in the south-southeast and southwest section, the land is under the influence of erosion. On the other hand, in the south-southwest and southeast sections of the region, the land is getting deposition.

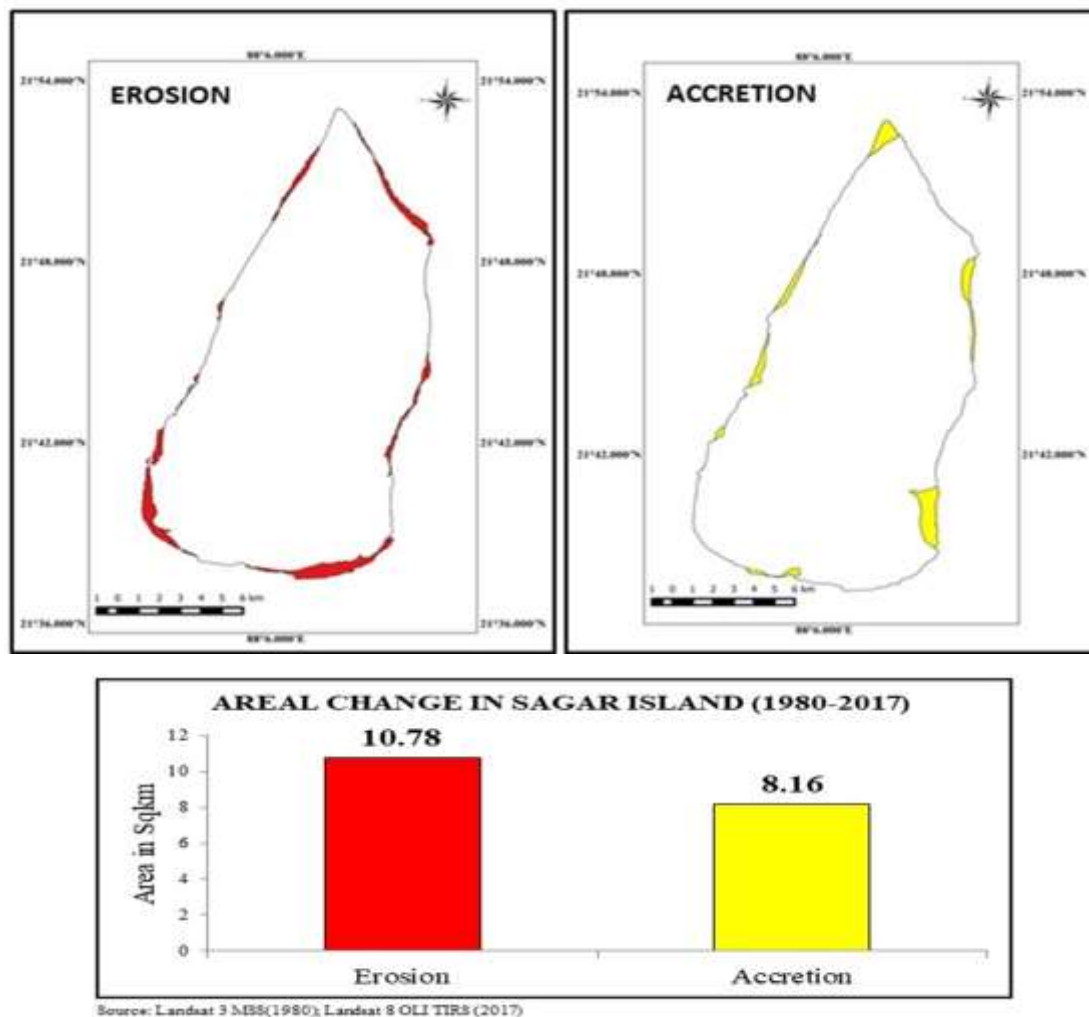
Figure 6. Areal Change in Sagar Island (Erosion-Accretion)

in the addition of land areas [14, 16, 28]. On the other hand, coasts subjected to erosion are considered to be more vulnerable due to the resultant loss of property and natural habitats [14]. For analysing the areal change in Sagar Island, we have taken the satellite images of 1980 and 2017 (figure 6). It is found that due to the breaching of the embankment, the problem of coastal erosion is increasing in the southern part of the island. The northern peak of the island is now under the influence of accretion and naturally growing mangroves. It can be observed from the chart that the total amount of eroded land is 10.78 sq.km whereas the total amount of deposited land is 8.16 sq.km. It indicates that both the processes of erosion and accretion are working together around Sagar Island.

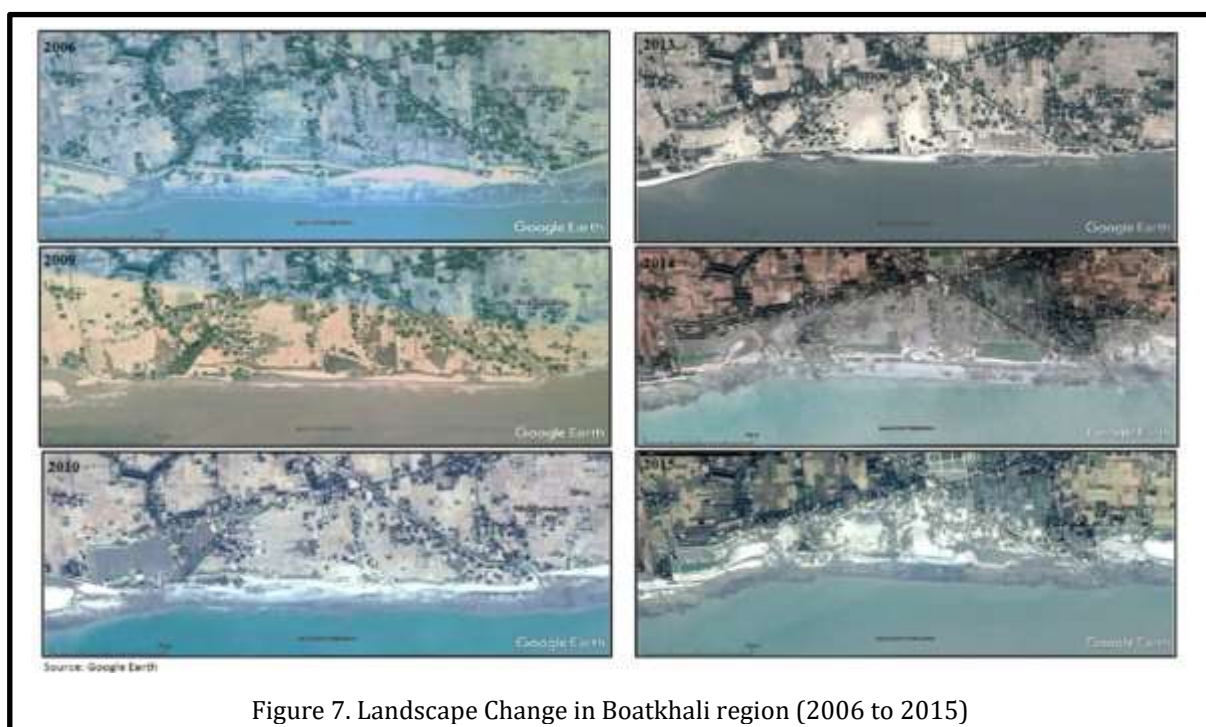
Figure 7. Landscape Change in Boatkhal region (2006 to 2015)

From the first three images of 2006, 2009 and 2010, it can be observed that most of the land is agricultural area. But with time the breaching of the embankment near the coast results in saltwater intrusion in the Boatkhal region. The previously fertile lands were converted into fishing grounds for the establishment of aquaculture farms. From the next three images of 2013, 2014 and 2015 it can be observed that most of the area is now dedicated to aquaculture farms. Due to the nearness of the farms with high tide line the salinity ranges are high in these areas. The number of settlements has also increased with time. The vegetation land is also found increased over the years. From the images, it is indicated that over the years the coastline has been shifted inland. The coast comes under the zone of diurnal tidal cycle. The impact of both high tide and low tide results in the mixing of freshwater with the saline water of the sea. During the highest high tide, the saline water reaches the inland resulting saltwater

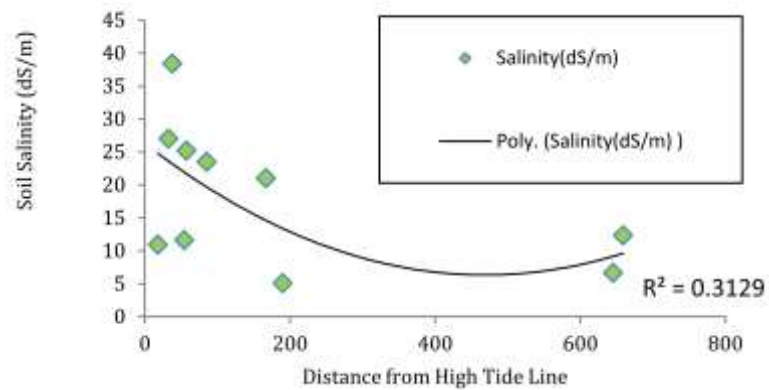
Figure 8. (A) Relationship between Soil Salinity and High Tide Line

As per the soil salinity classes given by FAO, it is found that paddy fields which are mostly affected by soil salinity fall under the range of 4-8 dS/m of moderately saline soil class. It is observed that behind the breached embankment the soil salinity value is 10.9 dS/m which indicates a high salinity range. It is the point nearest to the highest high tide line. Due to severe coastal erosion, the saltwater percolates

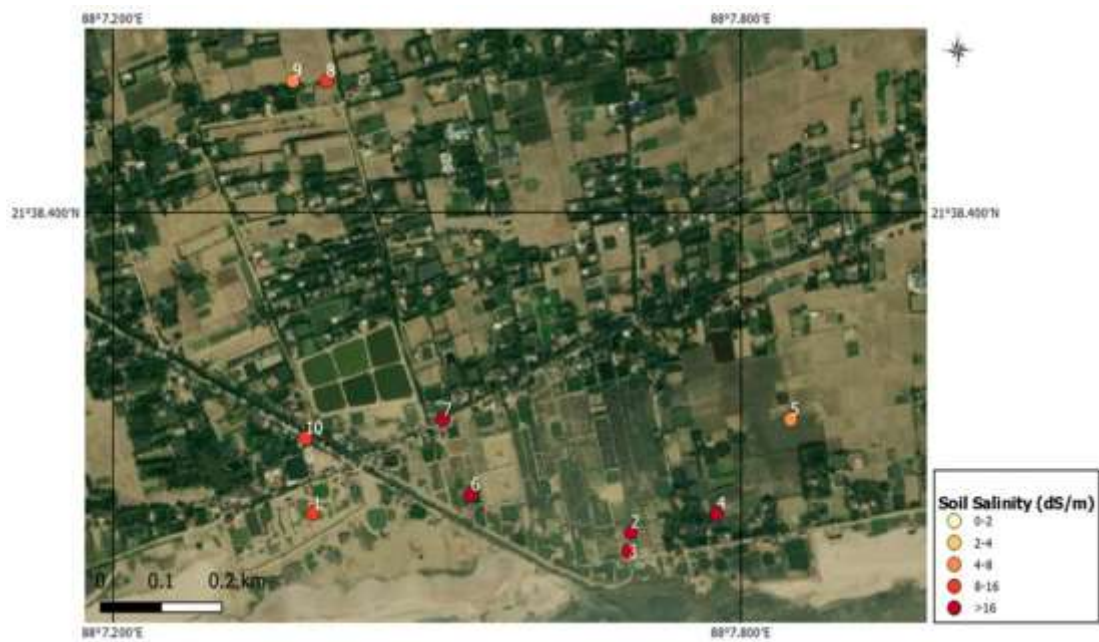
Figure 8. (B) Surface Salinity Map of Boatkhali (From Coast to Farmland)

through the ground into the freshwater coastal aquifers raising the levels of soil salinity. Paddy fields near the high tide line are also having high salinity values. The fishing grounds used for aquaculture farming are severely affected by the impact of saltwater intrusion. The highest salinity value is found in the fishing ground in the south-southeast part i.e., 38.4 dS/m. Paddy fields have been degraded in many places due to high saltwater concentration and now converted into fishing grounds.

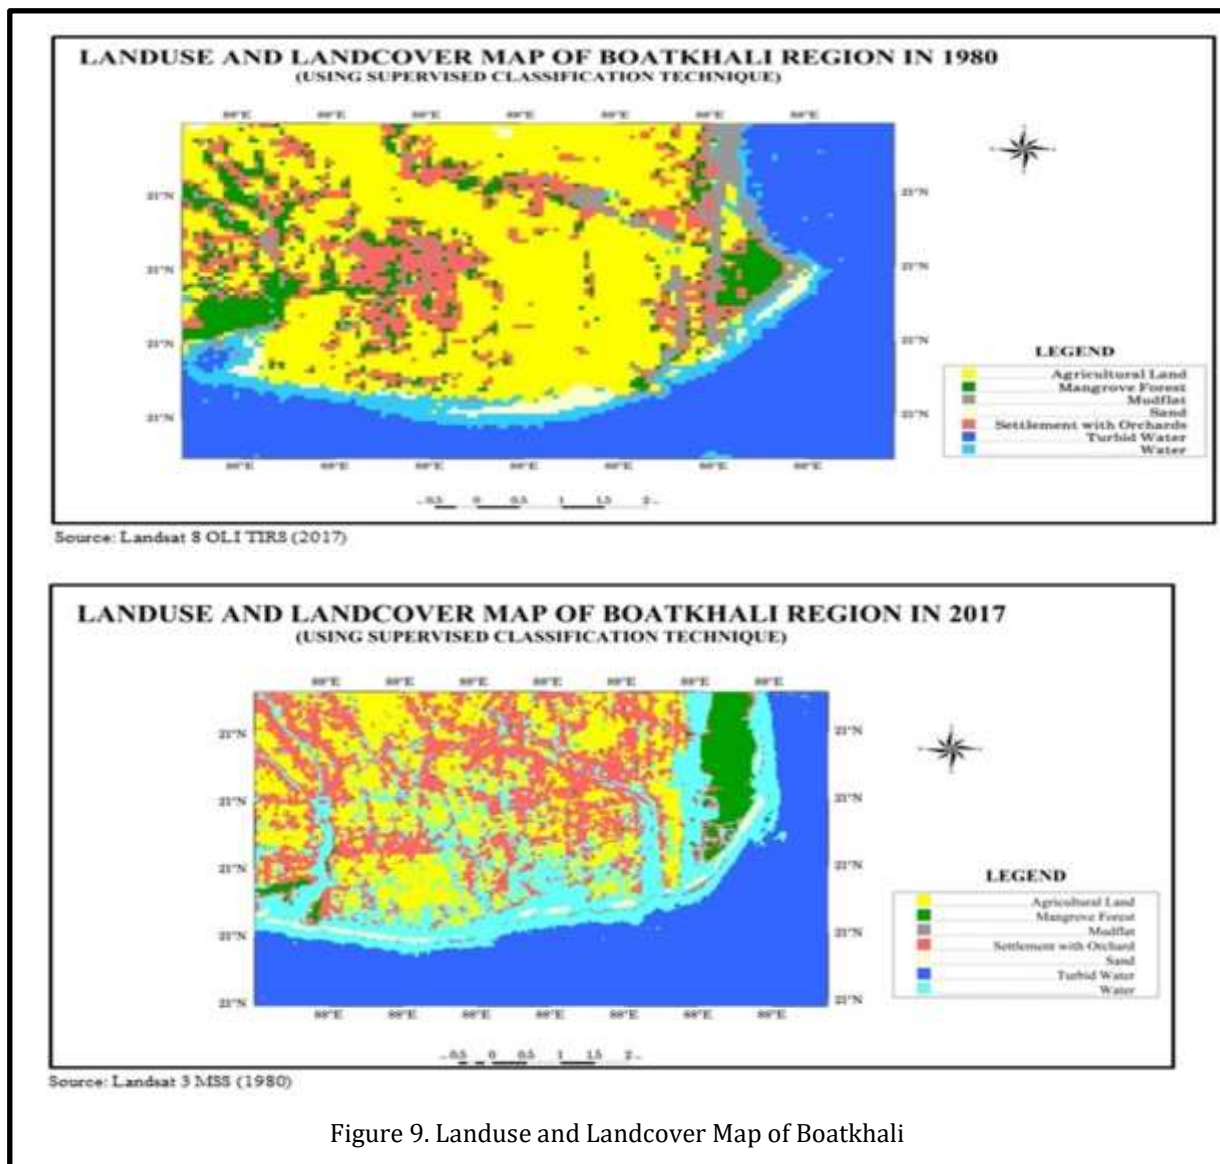
Figure 9. Landuse and Landcover Map of Boatkhali

time. Land-use and Land-cover maps have been prepared for the Boatkhali region for 1980 and 2017 using the supervised image classification technique (figure 9). It is observed from the map that in 1980 most of the area is agricultural land. Rice is the major crop of the region covering most of the croplands. In the south-western coast, small patches of mangrove forests are found along with the extreme south-east section. Very few areas are covered with fishing grounds. Mudflats are found in the south-western part of the region. The number of settlements with orchards is found to be very

dispersed in nature. The sand concentration along the southern section of the coast is also not so high. In 2017 it is found that the amount of agricultural land is in a decreasing trend. With the growing problem of saltwater intrusion due to severe coastal erosion, most of the fertile lands have been converted into aquaculture farms. The profitability of the income is more in fishing than the cultivation in salt-affected lands. The dominant mangrove species of the region are *Avicenia marina* and *casuarinas*. The mangrove forest is now found only in the south-eastern part of the region with a very small

patch around the south-southwest section. Sand concentration is high along the southern section of the region. Mudflats are found in the southern part. The area under mudflats is in decreasing trend. Sand concentration decreased in 2017. The numbers of settlements have increased over the years along with orchards. Settlements are in the form of small kuccha houses located mainly near the agricultural field.

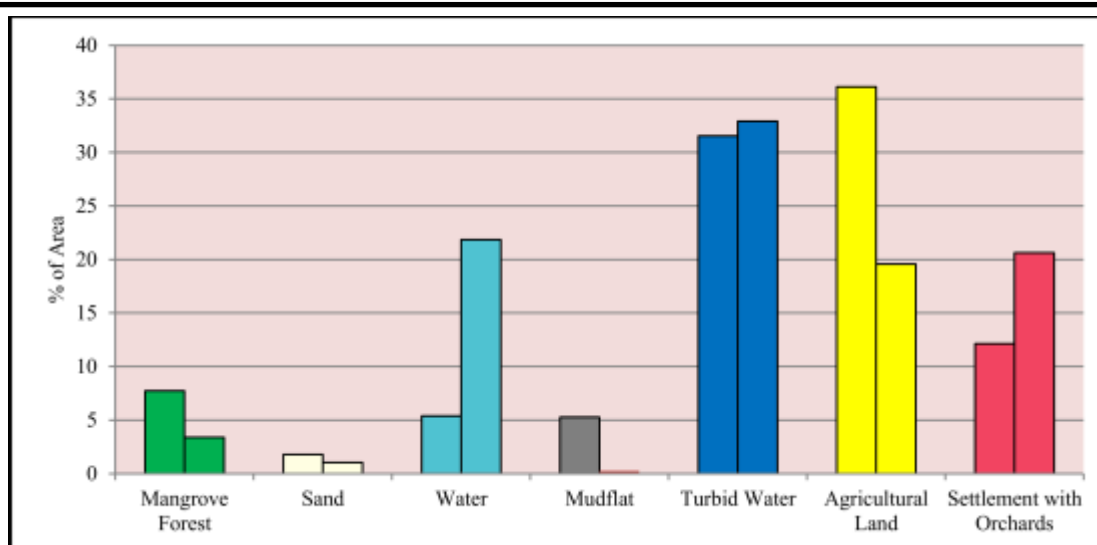
Figure 10. Change in Landuse and Landcover in Boatkhali (1980-2017)

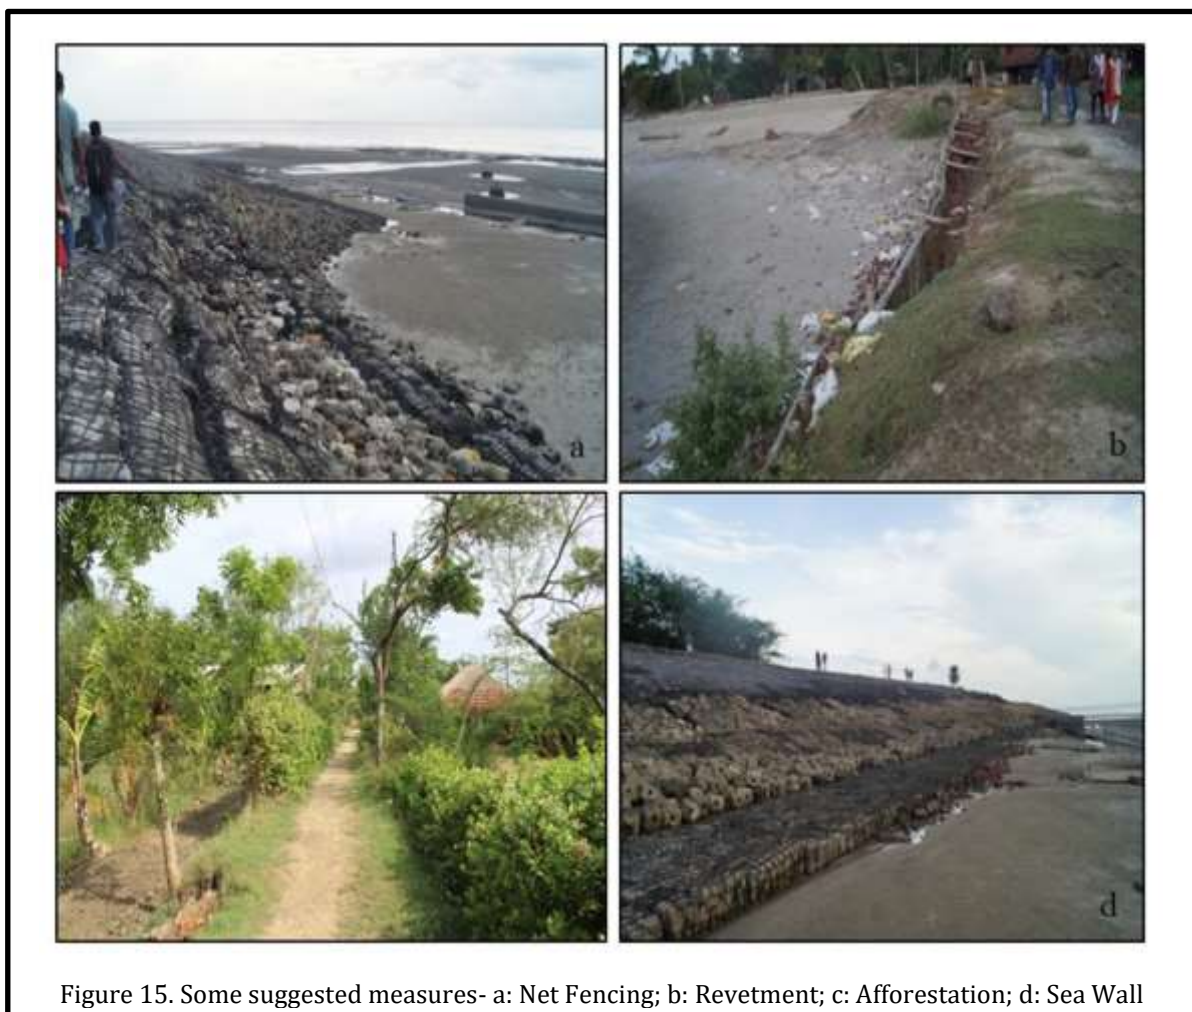
Figure 15. Some suggested measures- a: Net Fencing; b: Revetment; c: Afforestation; d: Sea Wall

- Nature should be given priority as it has the best healing power of regenerating land by natural processes.
- Information dissemination on extreme weather events like storm surges or severe cyclones.
- Coastal buffers i.e., mangroves area should be strictly protected from the intervention of people.
- Defense of the coastal land should be encouraged by providing beach nourishment.
- Awareness among the people of the affected areas about the protective and ecosystem function of the mangroves.

- Repairing of the brick-paved embankment along with the revetment. Post-monsoon is the best time for building the breached embankment.
